# The Construction and Failure of Calaveras Dam

## Purpose of Presentation

- Owner: Spring Valley Water Company (Current Owner City of San Francisco)
- 210 feet-high Semi-Hydraulic Fill Dam
- 2 ½ :1 Downstream; 3:1 Upstream Slope
- Reservoir Capacity: 100,000 Acre-Feet
- Construction 1913 to 1918 and 1918 to 1925

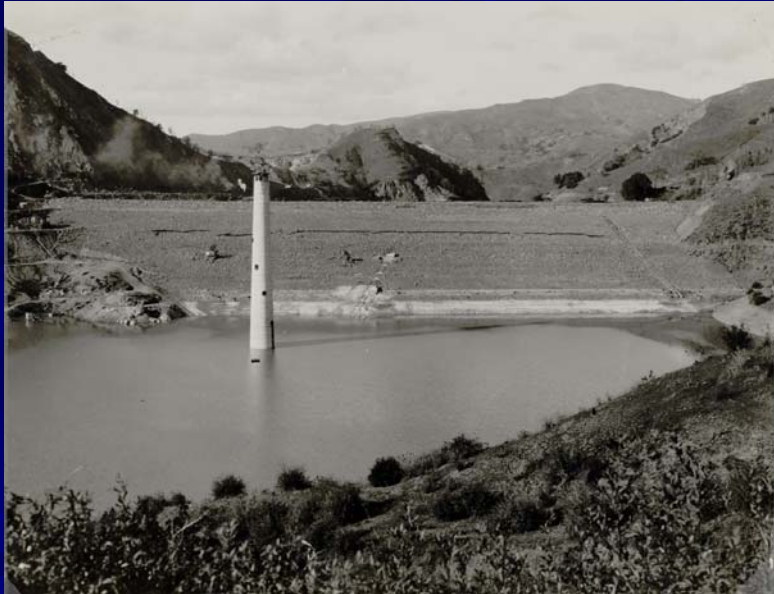
Two days before slide, March 22, 1918

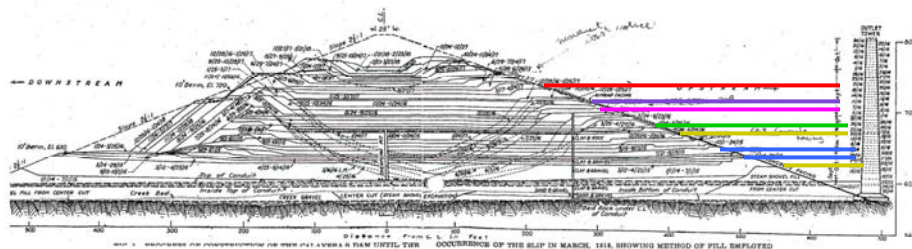
**Survey line 1: Elev. 729 to 731 – 1 ft. vertical movement**

**Survey line 2: Elev. 700 to 708 – 0.7 ft Horiz. 6/18 -6/21/17; 1.64 ft Horiz. to 3/4/18; 2.39 ft Horiz. To 3/23/18. Total Horizontal approx. 4 ft. 0.56 ft vertical movement**

**Survey line 3: Elev. 672 to 678 – 0.44 ft vertical movement**

**Survey line 4: Elev. 641 – 0.25 ft vertical movement**

**Reservoir W. S.: 2/12/18 - Elev. 641; 3/23/18 - Elev. 652**

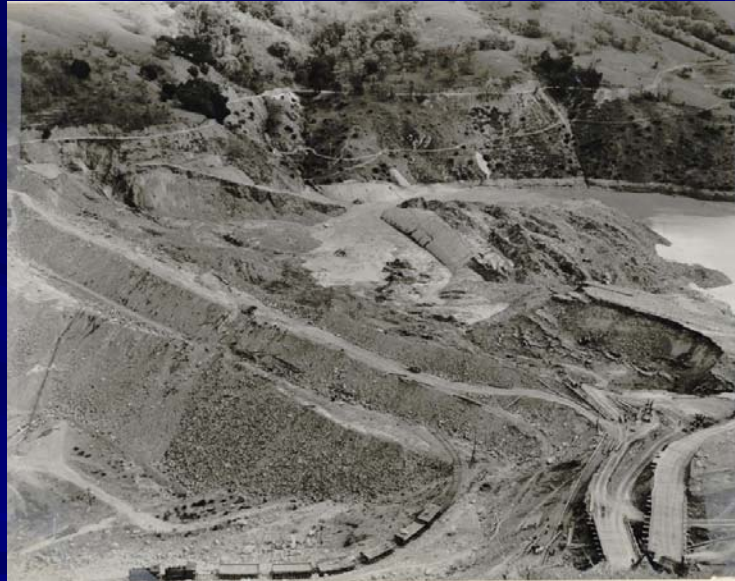
General view from top of Observation Hill.

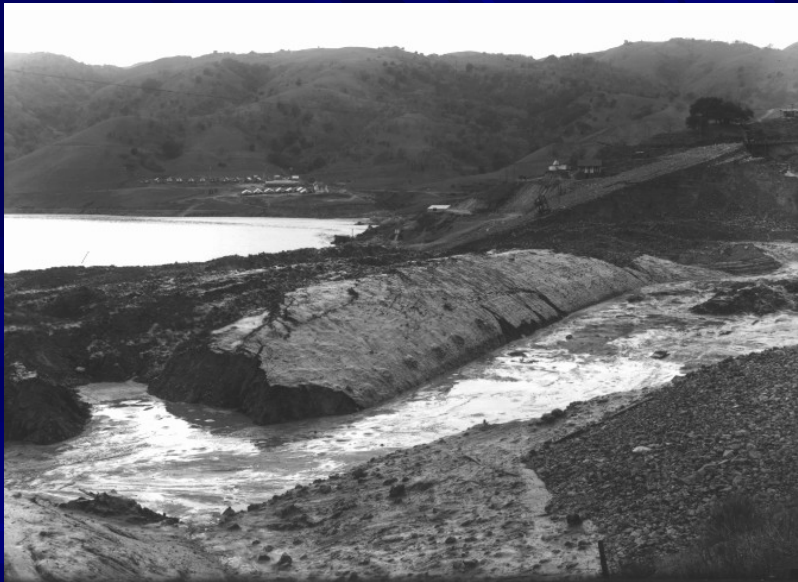
View of slipped material.

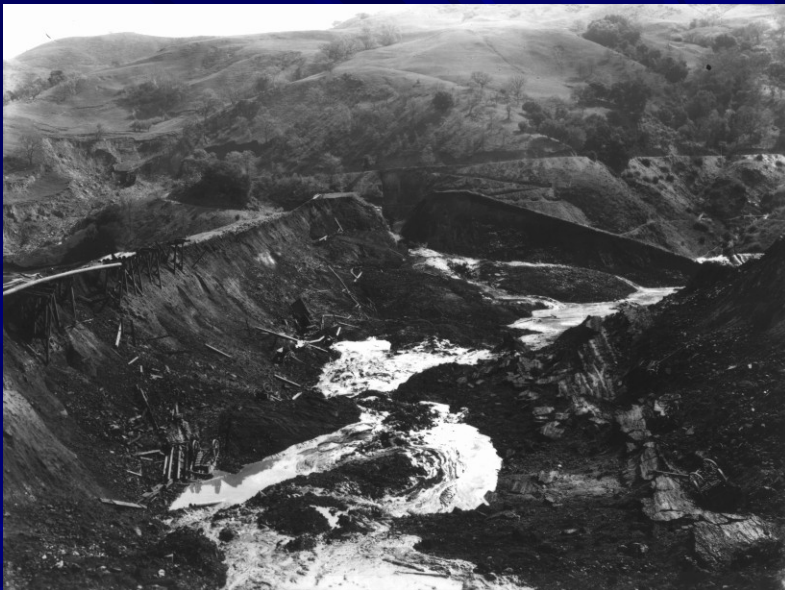
Day after slide, March 24, 1918.

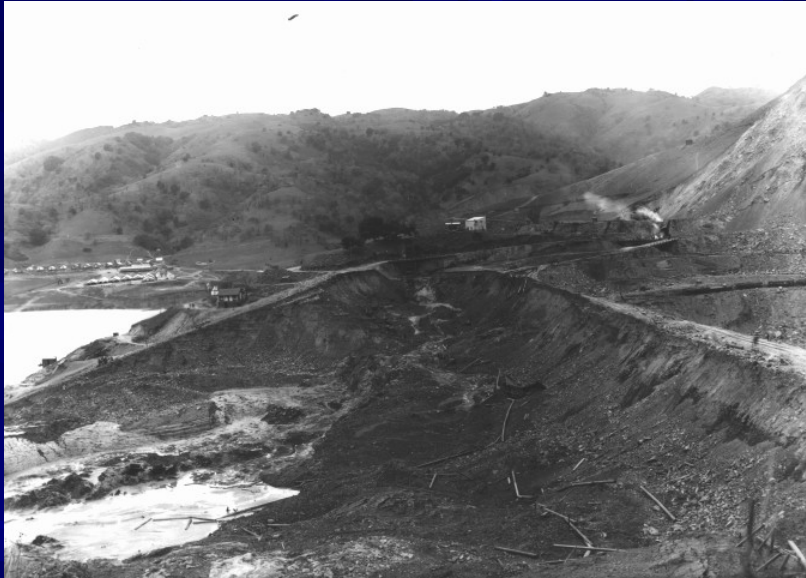
Looking west along centerline of dam.  
Remaining downstream fill is at right.

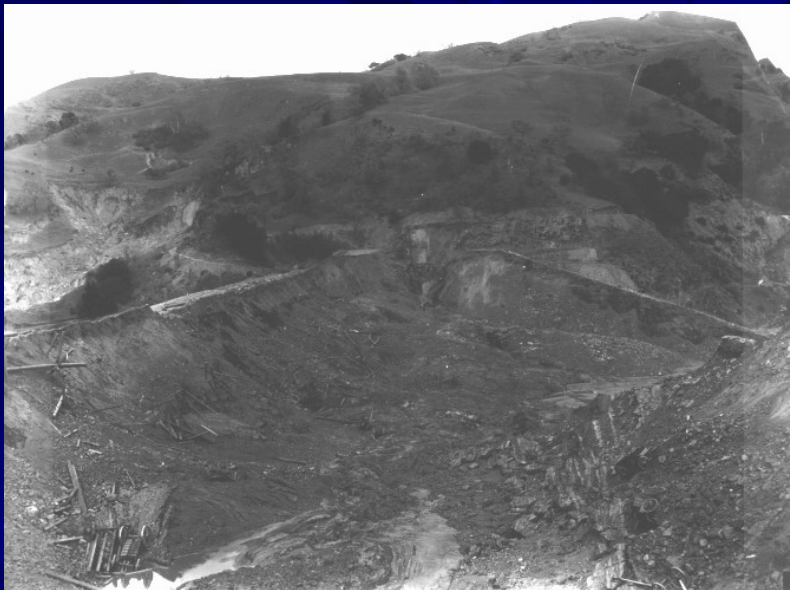
Two days after slide, March 25, 1918.
